# THROTTLE BODY REBUILD KIT AND NEW THROTTLE BODIES AVAILABLE

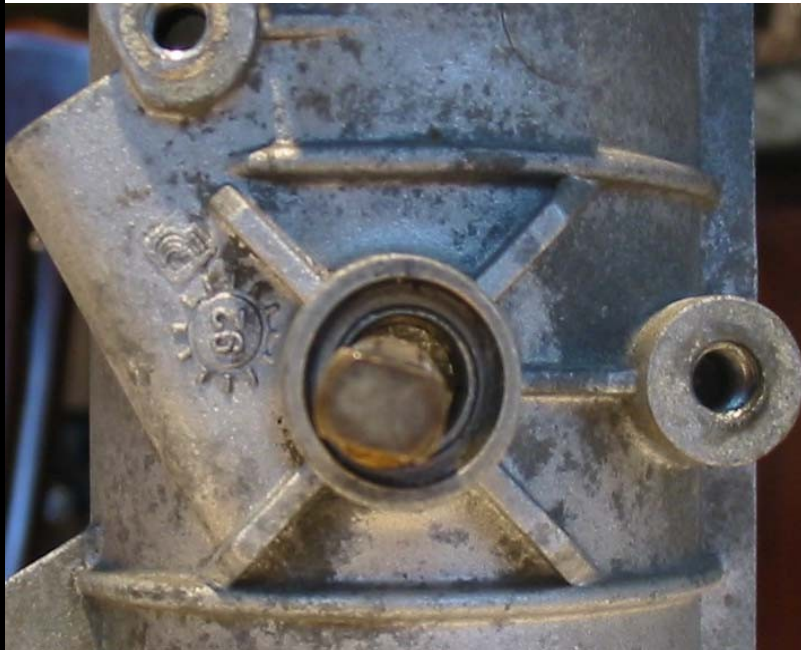
EXCESSIVE WEAR ON SHAFT SHOWN ON RIGHT SIDE

**EXCESSIVE WEAR ON SHAFT CAUSES WEAR ON THE THROTTLE BODY BUSHINGS WHICH ARE NOT REPLACEABLE**

**NOTE:** Wear varies from bike to bike, so if you hear any clatter we would recommend a rebuild before you wear the internal bushing.

Rebuild those throttle bodies before they have excessive wear and ruin the bushings! Spend now and **SAVE A LOT LATER!**
