THROTTLE BODY REBUILD KIT AND NEW THROTTLE BODIES AVAILABLE

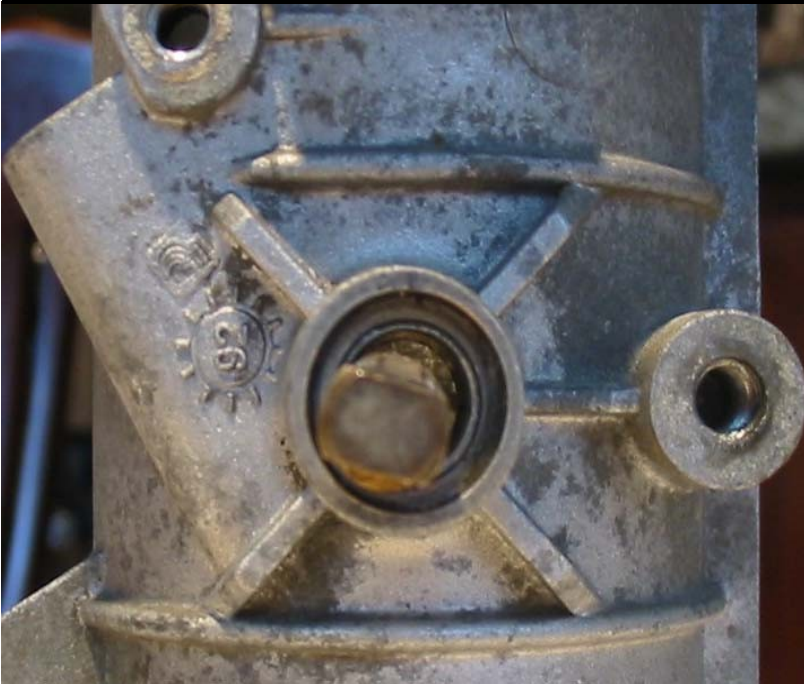
EXCESSIVE WEAR ON SHAFT SHOWN ON RIGHT SIDE

WEAR ON SHAFT CAUSES SLACK WHICH IN TURN WEARS THE THROTTLE BODY BUSHINGS – BUSHINGS ARE INCLUDED IN KIT

NOTE: Wear varies from bike to bike, so if you hear any clatter we would recommend a rebuild.
